Inconel 718 Milling example

Tool : CRRS 4060-15-18 ($\phi 6 \times CR1.5 \times 18$)
 Work material : Inconel 718
 Pocket size : 38 x 28 x 3 mm
 Coolant : Water soluble

Tool : CRRS 4060-03-18 ($\phi 6 \times CR0.3 \times 18$)
Work material : Inconel 718
Pocket size : 28 x 28 x 3 mm
Coolant : Water soluble

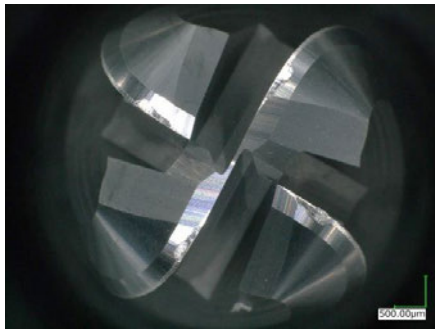
Bottom edge

There were no problems such as chattering vibration. No burrs or chattering was seen on the work.
 There is chipping on the bottom edge caused by the tool wear.
 Since it processed Inconel for 60 min, the tool damage was reasonable .

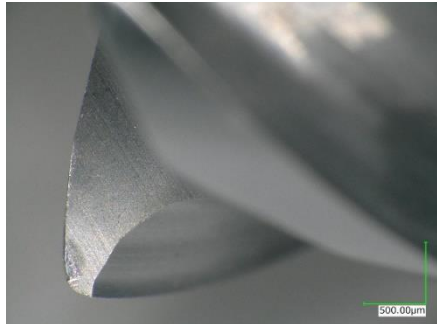
Rake face (Main flute)

There were no problems such as chattering vibration. No burrs or chattering was seen on the work.
There is no chipping on the rake face and the peripheral relief face, and the tool wear was normal.
